# Reconstruction of the Chalet of the Countess of Edla: preliminary evaluation of the effects of fire in the architectural surfaces

Graça Horta

This paper addresses the effects of fire on historic surfaces through the scientific analysis of the original mortars and pigments of the Chalet of the Countess of Edla, located in the Park of Pena (Sintra, Portugal). It is intended as a first approach to the study and characterization of the historical fabric in the context of the ongoing restoration project, promoted by Parques de Sintra-Monte da Lua, SA.

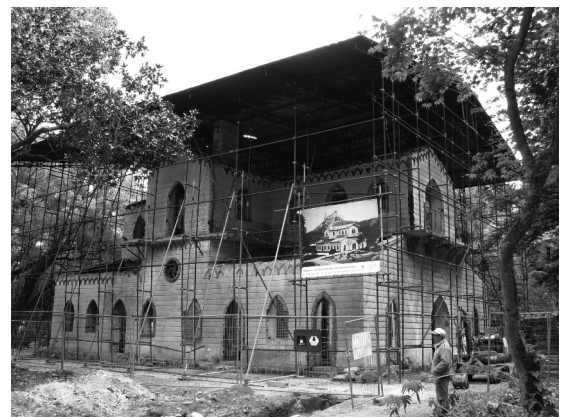
masonry structure resisted well, the fire consumed the wooden structure. It also had a destructive effect on the stone slabs from the cantilevered veranda (figure 2).

Fig. 2 Current condition after the fire in 1999 (September 2007).

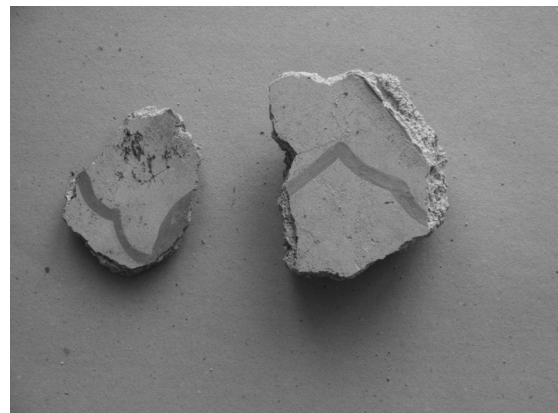
The samples 19-08-6 and 19-08-8 (figure 6) are both of the living-room and concerning the same decoration pattern, with decorative motives painted on the same substrate. The colour of this substrate is a rose tone in most areas, where the identified pigment is hematite. In some small areas, it has a light yellow tone where the identified pigment is goethite. It is not likely that these differences in colour were intentional in a decorative substrate with symmetrical patterns. Therefore, the effects of fire or the action of the water used by firemen have most probably caused a phase change in the original pigments. In order to explain this, two approaches are possible:

- The original pigment was goethite and the decorative substrate was yellow. The heat of fire has dehydrated the goethite with the consequent phase change to hematite that originates the rose tone. In some residual areas the temperature may not have been high enough for this phase change to occur and therefore some scattered yellow areas remained corresponding to the original goethite;

- The original pigment was hematite and the decorative substrate was of a rose tone. In this case, water absorption on some areas of the surface, together with the very humid local climate, have caused the hydration of the hematite with the consequent phase change to goethite which in turn caused the colour change to yellow.

The second approach seems more plausible because the uniformity of the rose colour in most of the painted areas in this room is more in agreement with an original application of a homogeneous colour. In this case the yellow areas should therefore correspond to affected and altered material.

Fig. 6 Samples 19-08-6 to 19-08-9.

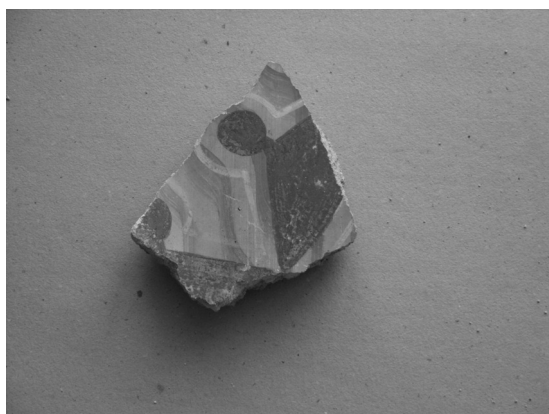
Also, the results of the samples 19-08-16 and 19-08-18 of the living room (figure 7), concerning a decoration near the ceiling, show the change of hematite to magnetite, a different phase of oxidation, probably caused by fire, and giving rise to a colour change from the original reddish to black.

Fig. 7 Samples 19-08-16 to 19-08-18.

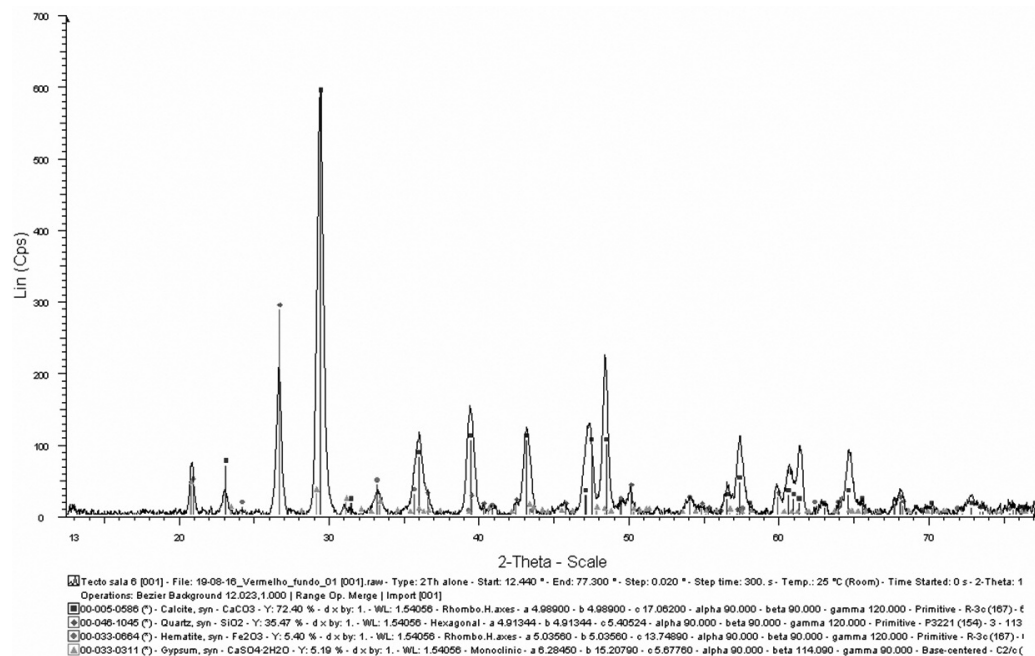
The graphic of figure 10 shows the results of sample 19-08-16 (hematite) and the graphic of figure 11 shows the results of sample 19-08-18 (magnetite).

Fig. 10 X-Ray diffraction for specimen 19-08-16.

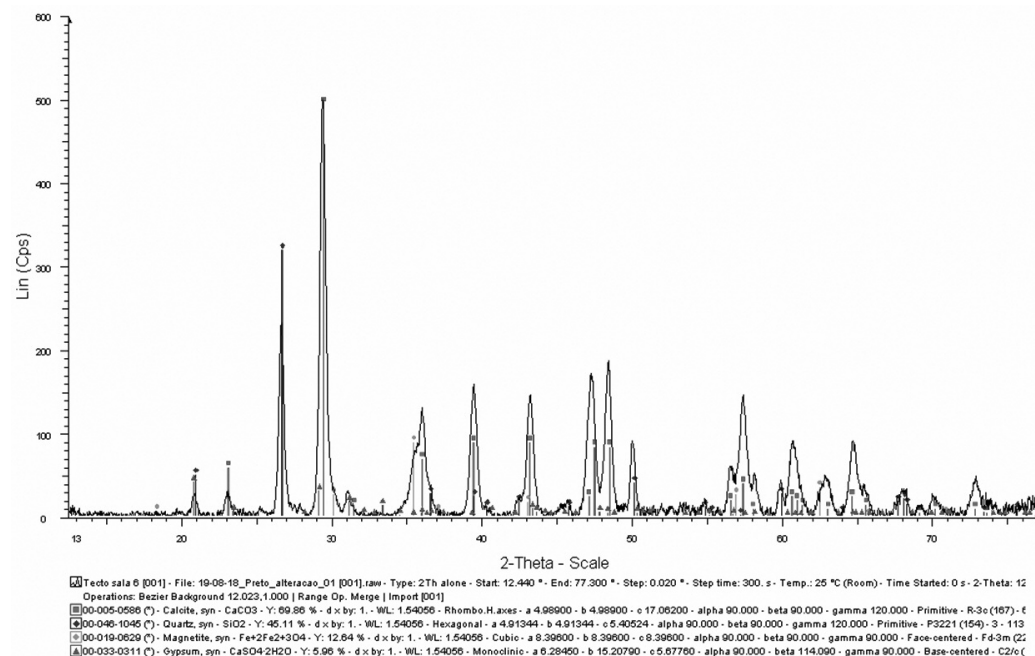
Fig. 11 X-Ray diffraction for specimen 19-08-18.

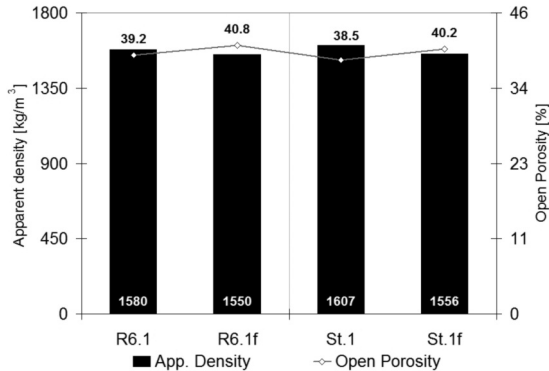
It may be observed that the mortars have very similar apparent densities and open porosities. Nevertheless, comparing mortars R6.1 and R6.1f and mortars St.1 and St.1f, there is a slight trend that may indicate that mortars subjected to high temperatures were altered in such a way that open porosity is slightly increased. This trend shall be further investigated with new collected samples both affected and non-affected by fire. On the other hand, in order to better evaluate this possible effect, non-affected mortars will be submitted to high temperatures in the laboratory and then tested.

Fig. 12 Apparent density and open porosity of the mortars.

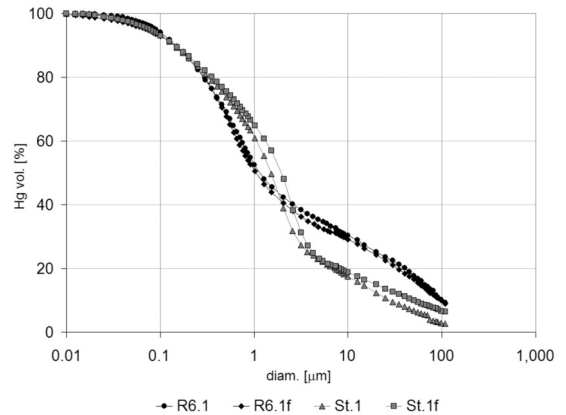
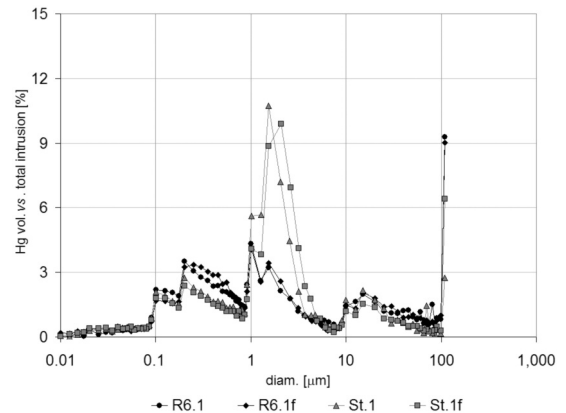
In a first approach, it can be said that the main differences in pore-size distribution are not related to the effect of fire. Mortars R6.1 and R6.1f have very similar intrusion curves and the same can be observed with mortars St.1 and St.1f. Therefore, these differences appear to be related to the area where samples were collected. It would not be surprising if mortars applied on different rooms of the building would have dissimilarities in their internal structures. As it is well known, this could arise from different manpower, curing conditions, amount of mixing water, etc.

One fact deserves however a specific reference: mortars St.1 and St.1f were collected from the area of the building that was the most affected by the fire. The significant distinction on the respective intrusion curves in the range of the 1.0 to 1.5 mm diameters is therefore a feature that will deserve a more detailed analysis together with the future tests of open porosity previously mentioned.

Fig. 13 Cumulative mercury intrusion curves.

Fig. 14 Incremental mercury intrusion curves.
