Conservation of the historical render in the Church of Nossa Senhora da Assunção in Elvas

Sofia Salema

Abstract

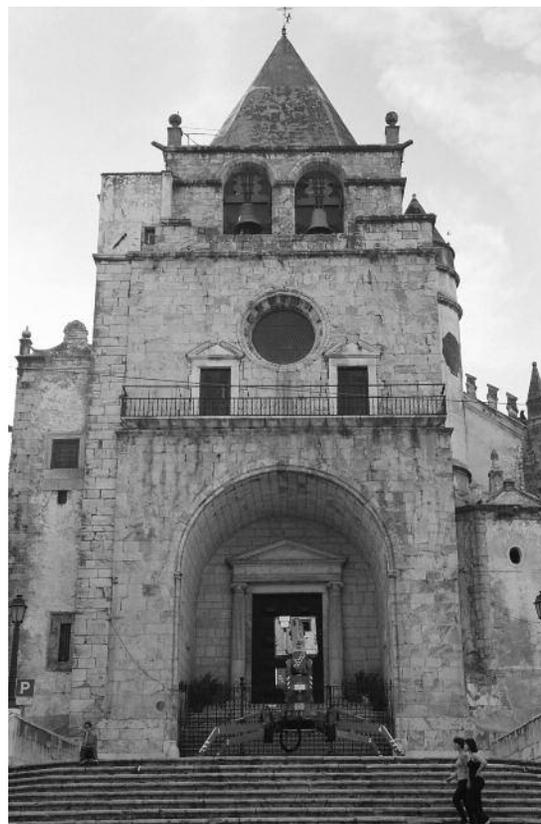
The façade was undoubtedly one of the most problematic situations, due to the state and degree of alteration of the stone material and the non-functionality of the joints and also due to the architectural meaning of the façade for the whole monument and for the image of the city (fig. 1).

Fig. 1 Church of Nossa Senhora da Assunção before the works of conservation.

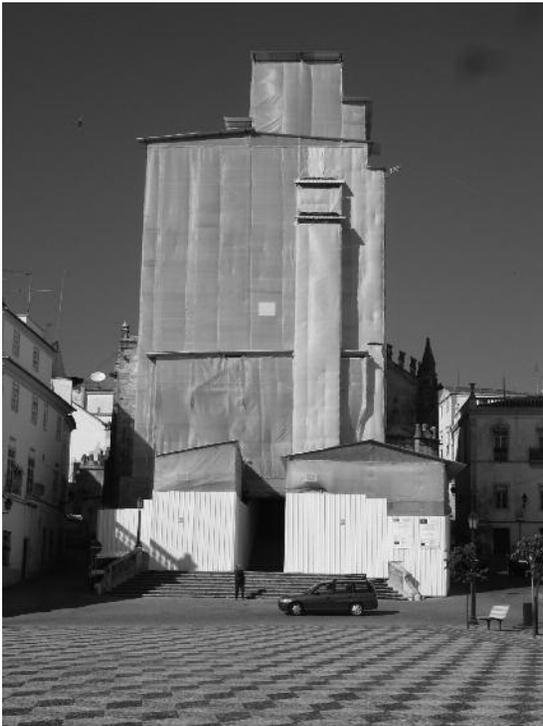
Fig. 2 Church of Nossa Senhora da Assunção during the works of conservation.

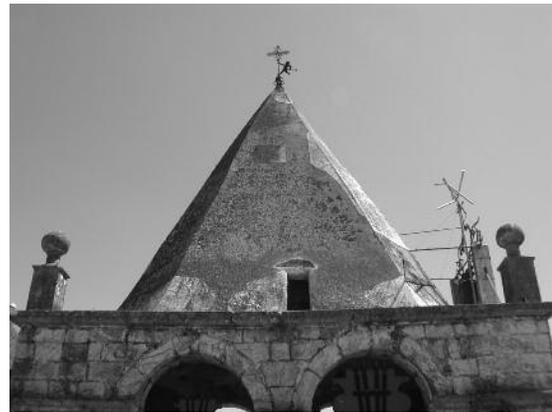
During the works on the site we discovered, on the top of the tower, in the pyramid part, under the finishing layer of the non decorated render, a previous decorated render that simulates stone masonry with raised joints (figs. 3-7). In fact, when preparing the conservation project for the restoration of the façade we used mechanical elevators for a prior study of the conservation and materials' diagnosis but, at that time, with this equipment and weather conditions, it was not possible to observe any traces of the existence of this historical render.

Fig. 3 Initial state of conservation of the pyramidal tower.

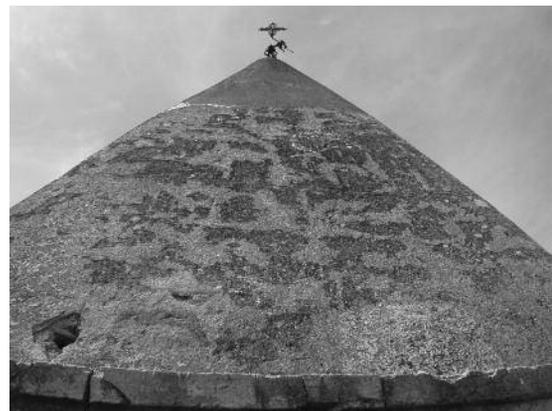
Fig. 4 Detail of the initial state of conservation.

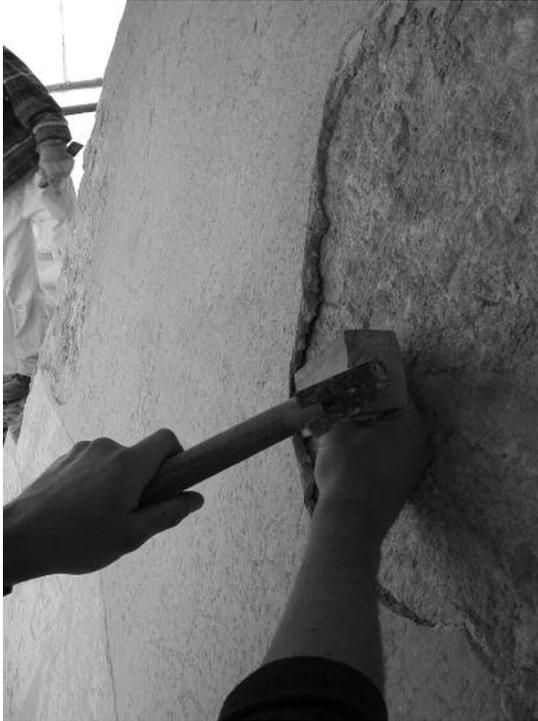
Fig. 5 Removal of the non decorated recovering render.

- Removal of previous non-decorative and non-functional render. After removal, we could identify evidence of different types of uncovered decorated historical renders. There were renders where we could see the aesthetic appearance and formal techniques in spite of some material degradation. There were also uncountable

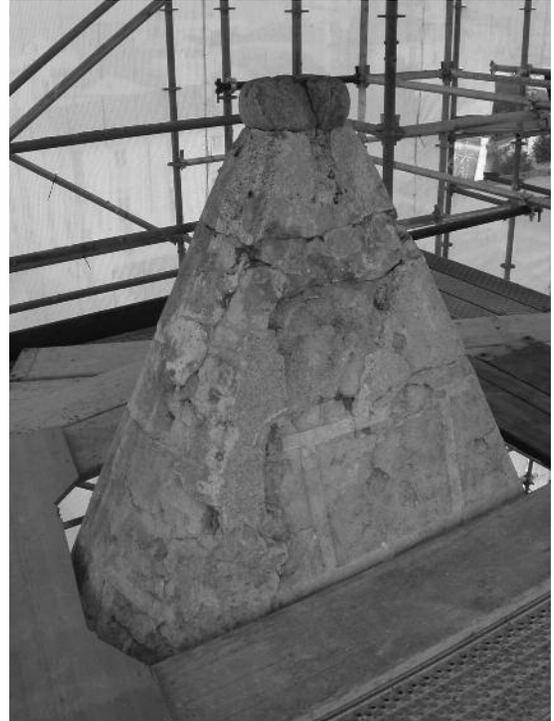
Fig. 7 Detail of the previous decorated render.

traces that we could reconstruct visually, having a full panorama of the decorative scheme (figs. 5-7);

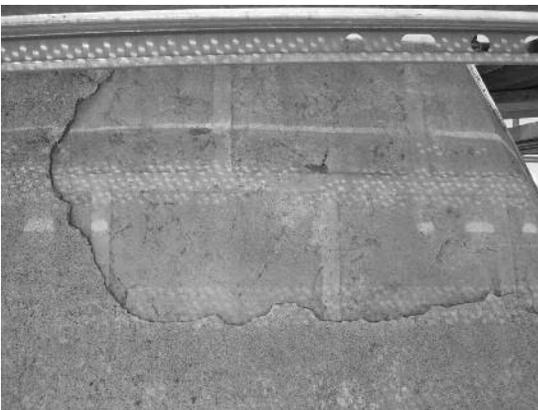
Fig. 6 The previous decorated render discovered under the layers of non decorated recovering render.

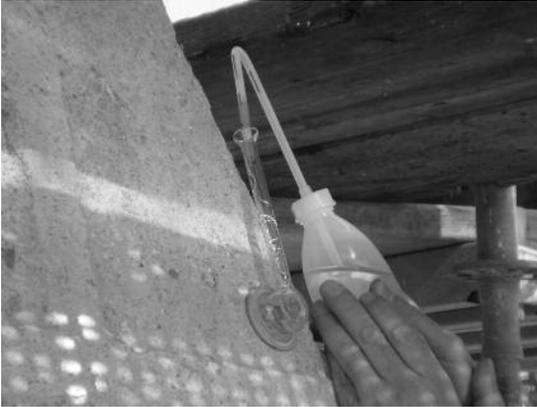
Fig. 8 In loco, water absorption experimental tests were made to characterise the original materials.

- Characterization of the original materials, with *in loco* experimental tests, to define the restoration mortars' properties (figs. 8-9);

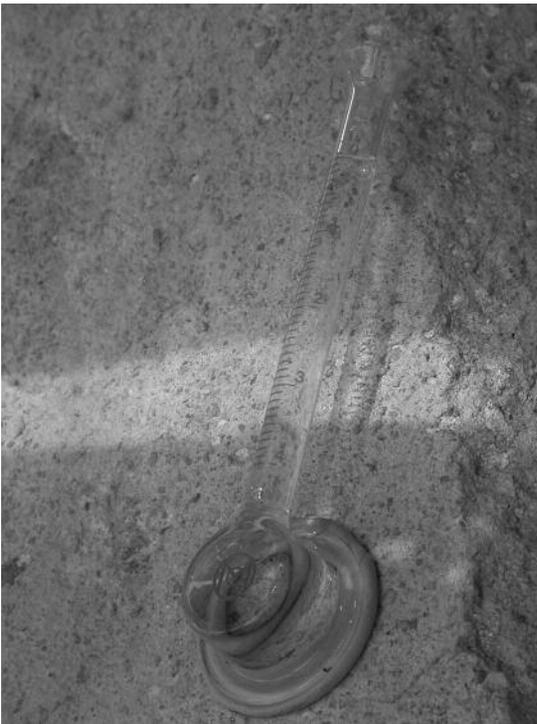
Fig. 9 Detail of the experimental tests.

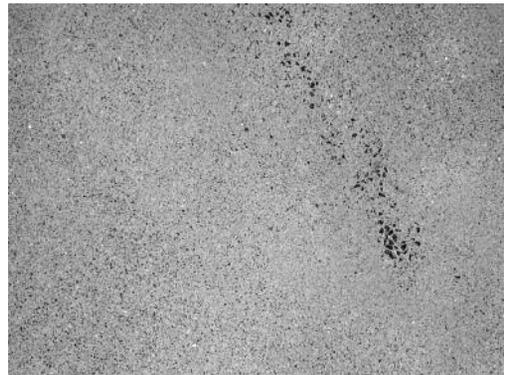
Fig. 14 Surface render's detail.

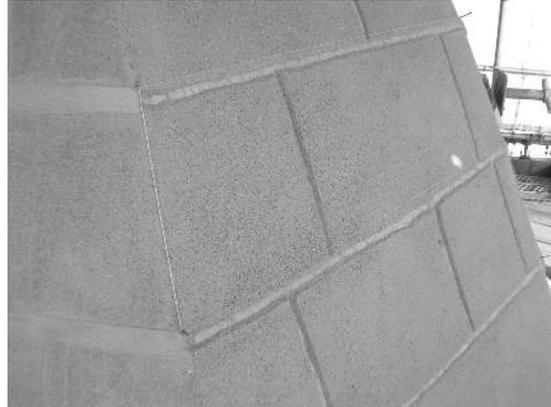
Fig. 19 Surfaces details the with the furrows.

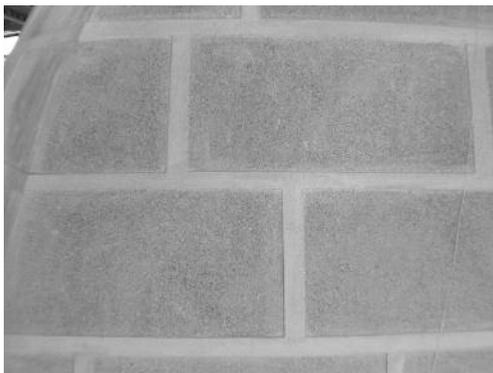
Fig. 24 Surfaces details after integration of the lacunas.

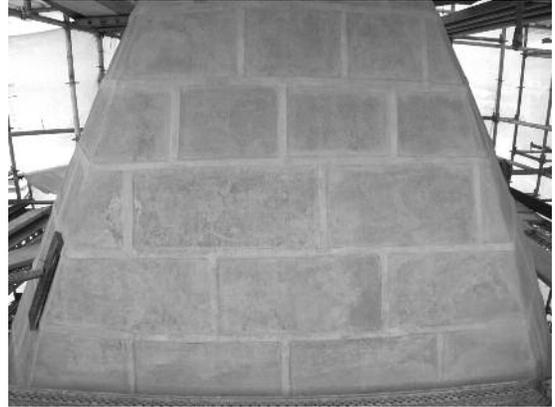
Fig. 25 Architectural surface after the integration of the lacunas.

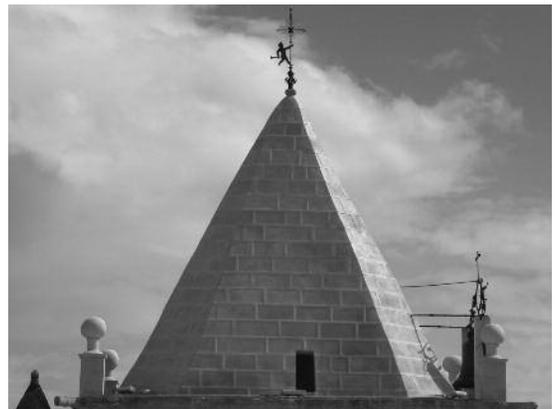
Fig. 26 The pyramidal tower after the conservation and restoration works.

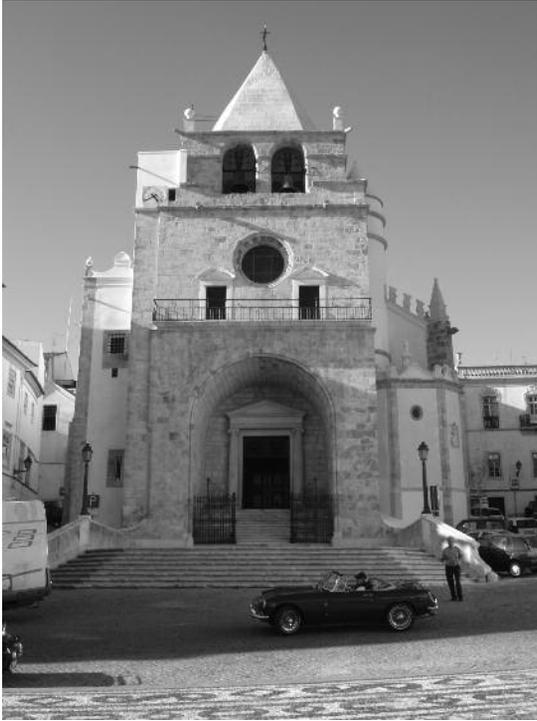
Fig. 27 The main façade after the conservation and restoration works of the historical mortars.
